Engineering News

Vol. 67. 505 Pearl Street, New York No. 5

The Cambridge Subway

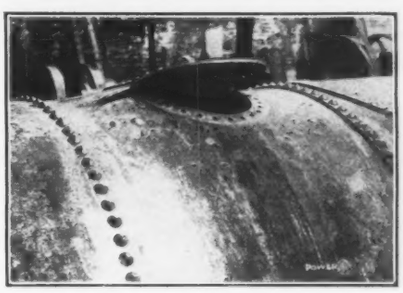
Fig. 1. Manhole Patch Ruptured at 335-lb. Pressure in Test at Providence, R. I., Boiler 4092

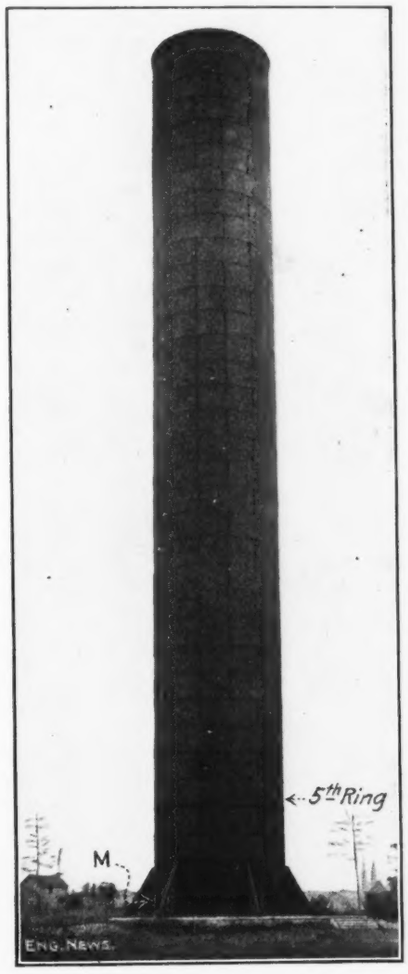
FIG. 1. STANDPIPE AT SHEBOYGAN, WIS., BEFORE FAILURE

The underlying cause of the collapse was undoubtedly the weakened condition of the plates and rivets in the bottom rings, brought on by nearly twenty-five years of exposure to the action of the water and ice. The direct cause, however, is of more interest to the engineer of the present as it may emphasize the importance of meeting such phenomena in the design of structures subjected to similar stresses. The failure was caused by expansion of ice which was permitted to accumulate to such an extent as to explode the lower sections. The cause of the formation of this ice will be discussed later, and proper conclusions may then be drawn by the reader as to how to cope with such conditions.

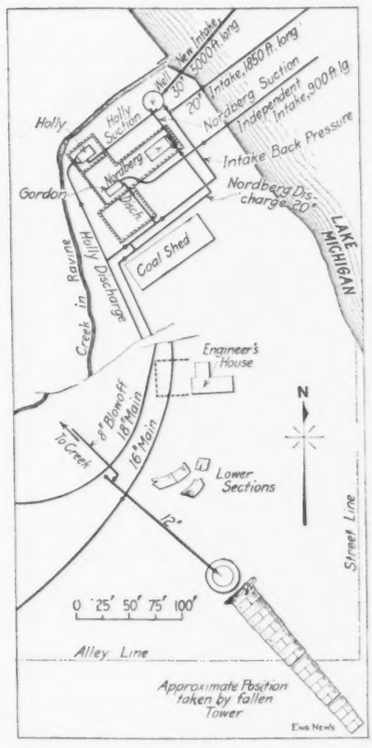
FIG. 2. PLAN OF WRECKED STANDPIPE AT SHEBOYGAN, WIS., IN RELATION TO PUMPING STATION AND ENGINEER'S HOUSE

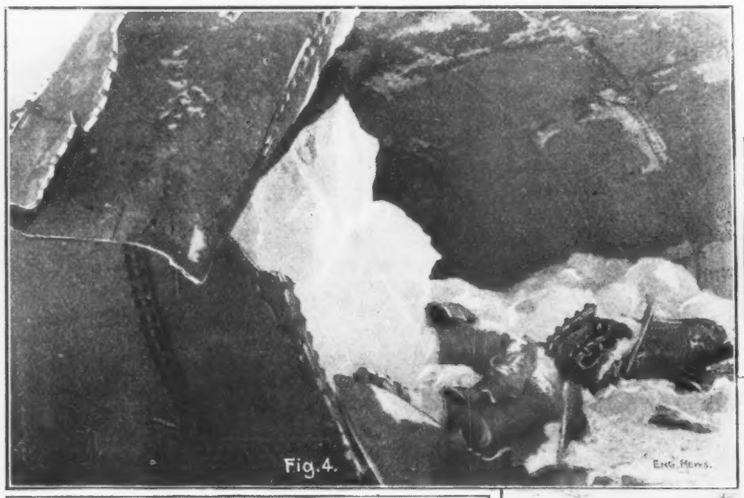
FIG. 4. LOOKING INTO LOWER END OF WRECKED STANDPIPE, SHEBOYGAN, WIS.

FIG. 7. FOUNDATIONS AND LOWER END OF STANDPIPE

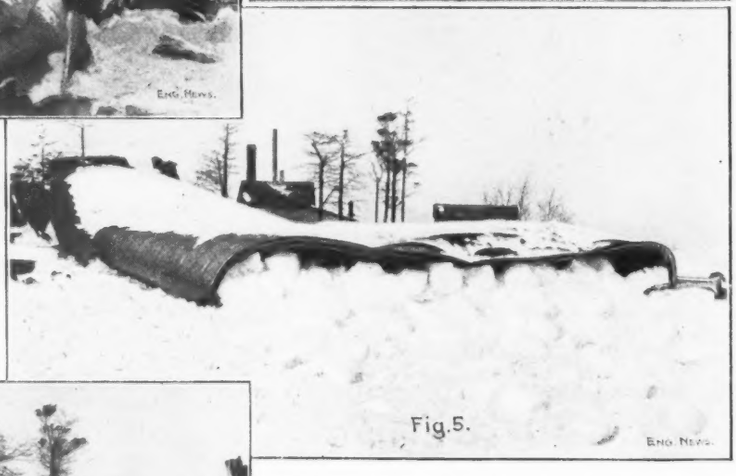
FIG. 5. BLOCKS OF ICE IN TOP END OF WRECKED STANDPIPE, SHEBOYGAN, WIS.

FIG. 6. LONGITUDINAL BREAKS AND ICE IN STANDPIPE

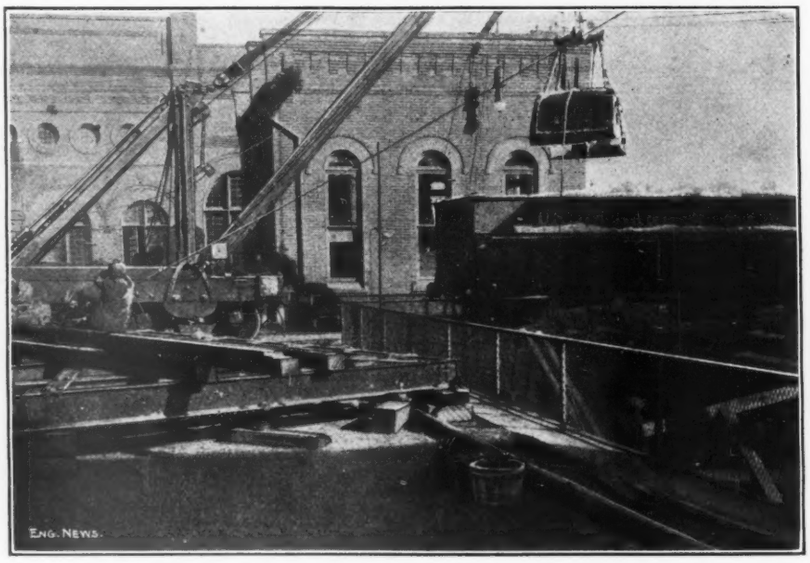
On Sunday evening, Dec. 31, 1911, at 5 p.m., the ice began to rapidly accumulate in the wet-well. Both ice elevators were put in operation, but the ice came in faster than it could be removed and the machine became more and more heavily loaded. At 10 p.m. the worm-wheel of the north machine broke, and at 11 p.m. the chains carrying the buckets on the south elevator broke, thus putting both machines out of service. On Monday morning, Jan. 1, 1912, the outlook was very gloomy, the well full of ice, only enough water to supply one pump coming through the tunnel. Monday being a holiday, the employees of the department were mostly off duty and it was difficult to collect men enough to accomplish anything. A derrick and hoisting engine belonging to the department were erected at the well, and inquiries started in every direction for machines which could be used for lifting the ice from the well. From the wreck of the south ice elevator, the north elevator was repaired and put in service. On Tuesday a derrick was obtained from the Terminal Railroad Association, and a clam-shell bucket from the Union Sand & Material Co. Late Tuesday night it was found that the derrick would not operate the bucket. Another derrick was obtained from the Terminal, but on bringing it over the Water-Works Ry. about 5 a.m.,

Fig. 3. Using Clam-shell Bucket to Take Ice from the Wet Well, St. Louis Water Works Pumping Station
